# **INDOOR AIR QUALITY ASSESSMENT**

**Registry of Motor Vehicles  
175 Cabot Street  
Beverly, Massachusetts**

Prepared by:  
Massachusetts Department of Public Health  
Center for Environmental Health  
Emergency Response/Indoor Air Quality Program  
March 2007

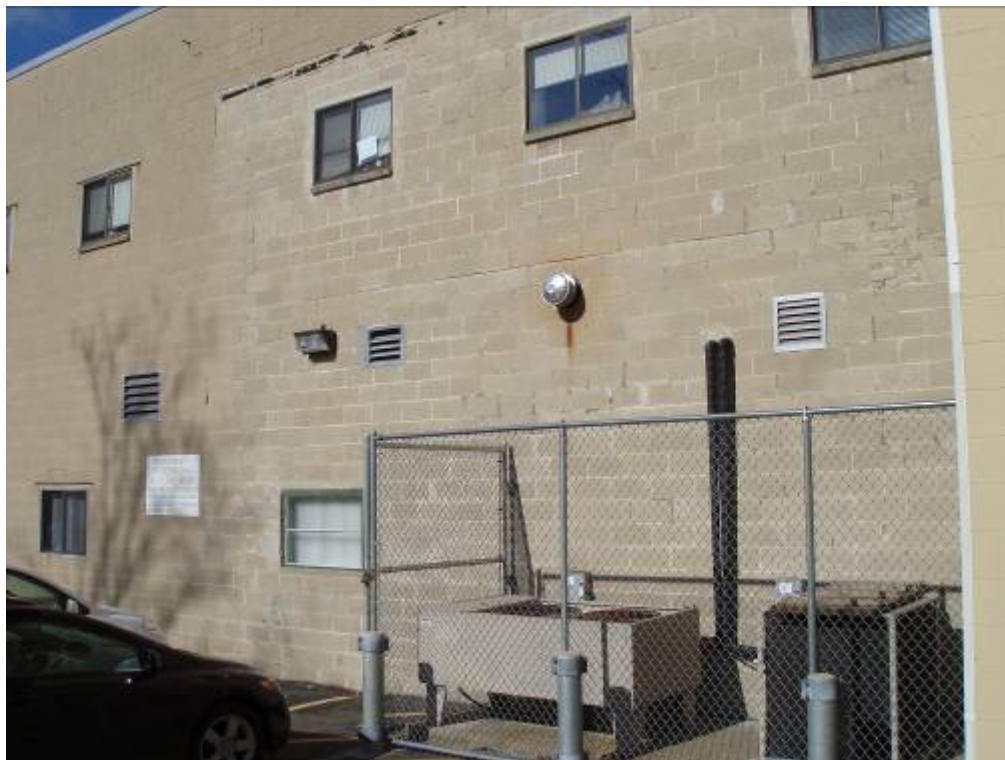
**Picture 1**

As indicated in the DOS report (MDLWD, 2005), another potential source of odors are the fresh air intakes, which are located on exterior walls in the parking lot (Picture 1). Due to the close proximity of these air intakes to the parking lot, there is a potential for entrainment of vehicle exhaust and/or other odors that may be present outside of the building in this vicinity.

**Fresh Air Intakes on Exterior Wall near Parking Lot**

2. Have building management consult with an HVAC consultant to determine whether the existing fresh air intake system has the capability to provide a sufficient supply of outside air. Increased fresh air supply is recommended given the elevated levels of carbon dioxide measured during both the previous DOS and current MDPH assessments.

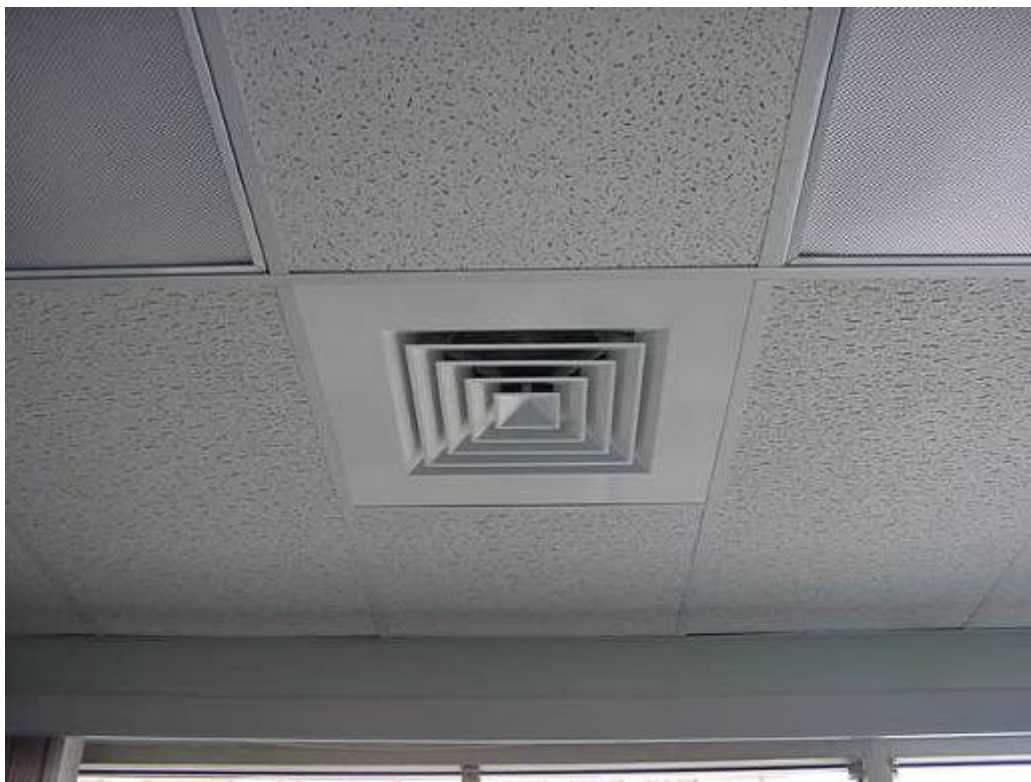
**Picture 2**

Mechanical ventilation is provided by air-handling units (AHUs) located in the ceiling plenum. Fresh air is drawn into the AHUs through air intakes on the exterior wall and delivered to occupied areas via ceiling-mounted air diffusers (Pictures 1 and 2). Return air is drawn into ceiling-mounted vents and ducted back to the AHUs (Pictures 3 and 4). Digital wall-mounted thermostats control the heating, ventilating and air-conditioning (HVAC) system and have fan settings of “on” and “automatic”. Despite the 2005 recommendations by DOS, the thermostats were observed to be set to the “automatic” setting (Picture 5) at the time of the MDPH assessment. The automatic setting on the thermostat activates the HVAC system at a preset temperature. Once the preset temperature is reached, the HVAC system is deactivated. Therefore, no mechanical ventilation is provided until the thermostat re-activates the system. Without a continuous source of fresh outside air and removal via the exhaust/return system, indoor environmental pollutants can build-up and lead to indoor air quality/comfort complaints.

**Ceiling-Mounted Air Diffuser**

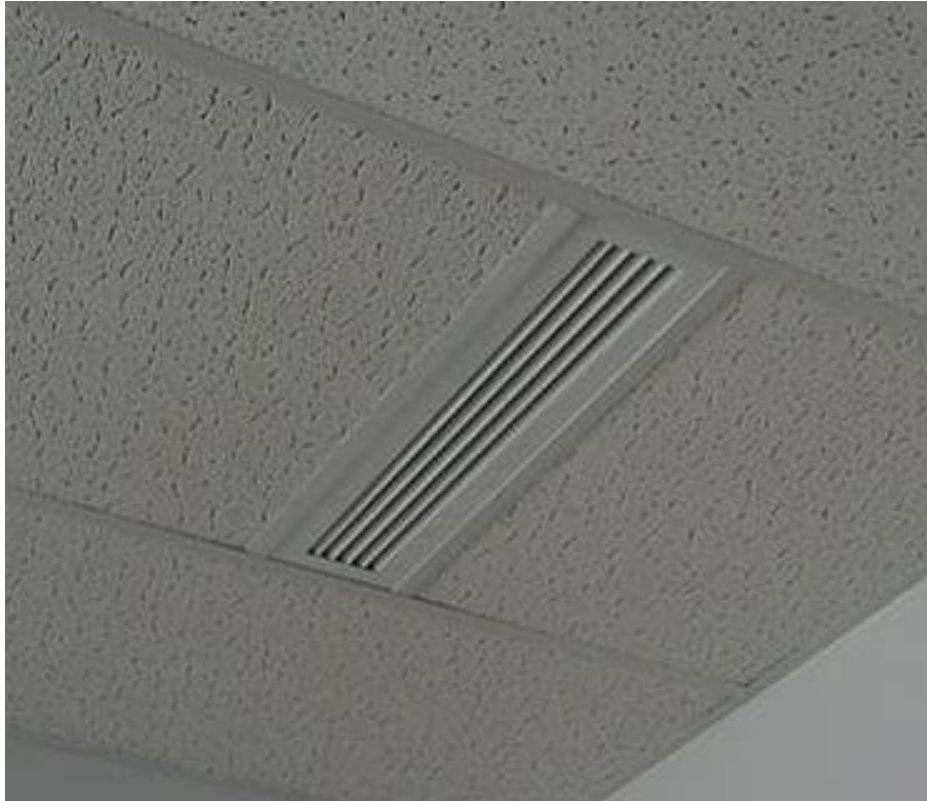
**Picture 3**

**Ceiling-Mounted Return Vent in Office**

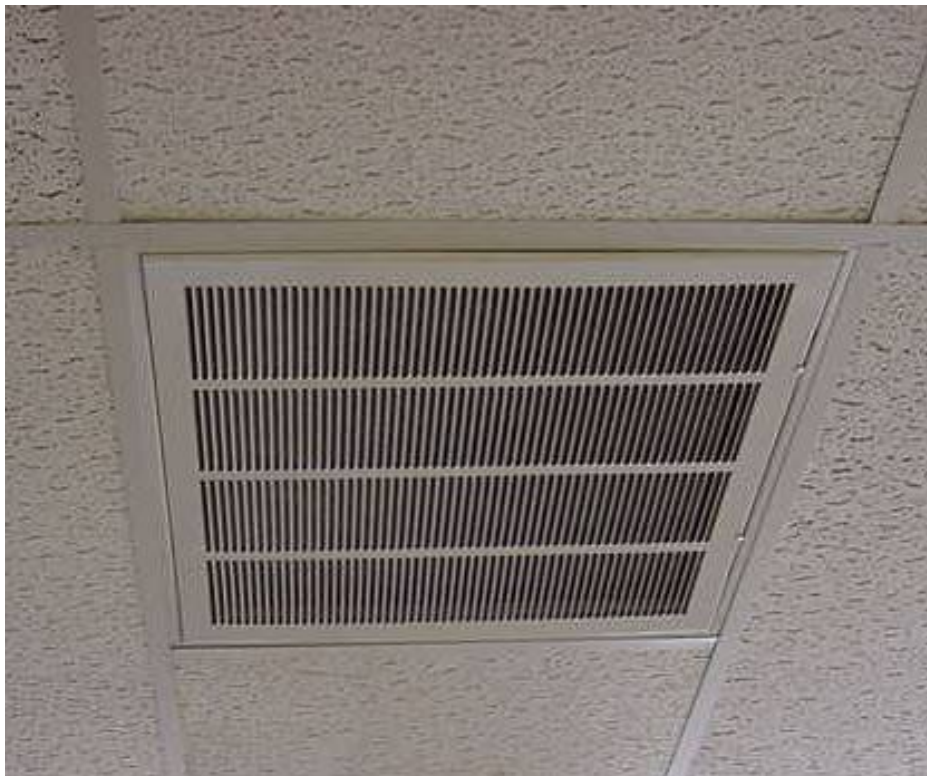
**Picture 4**

**Ceiling-Mounted Return Vent in Common Work Area**

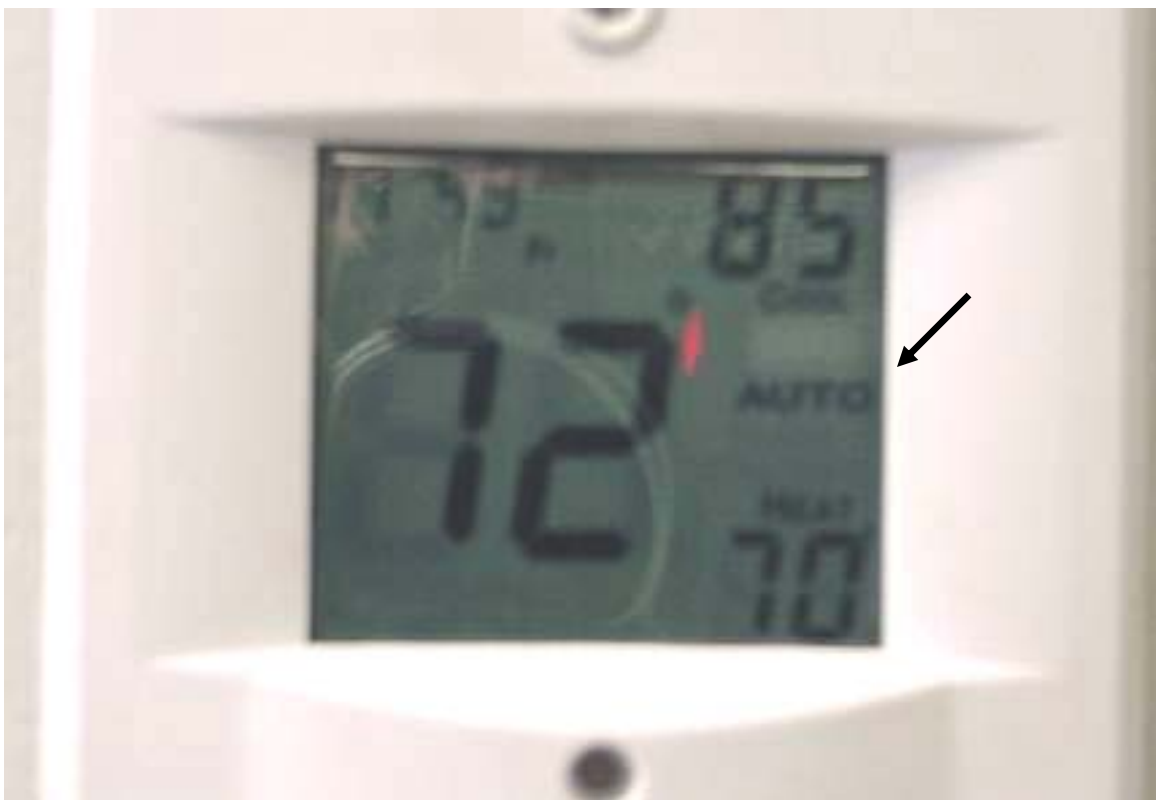
**Picture 5**

**Thermostat with Fan in “Auto” Mode**

1. Implement previous recommendations made by MDLWD (MDLWD, 2005). Most notably the setting of thermostat controls to the fan “on” position to provide constant supply and exhaust ventilation during periods of occupancy.

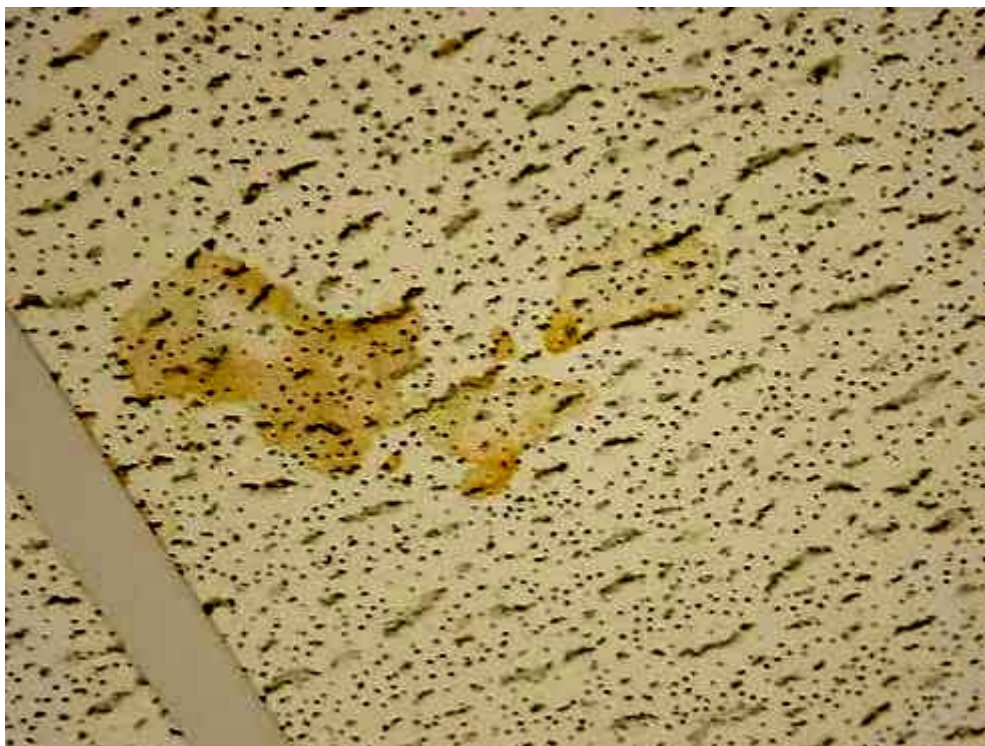
**Picture 6**

A few areas had water-damaged ceiling tiles (Picture 6). Water-damaged ceiling tiles can provide a source of mold and should be replaced after a water leak is discovered and repaired. Occupants expressed concern regarding past plumbing leaks that occurred above work station 1 in the licensing area. CEH staff observed a large metal drip pan located below plumbing fixtures on top of ceiling tiles in this area (Picture 7). The drip pan was empty at

**Water Stained Ceiling Tile**

8. If plumbing leak above licensing station 1 is repaired, remove drip pan to prevent a falling/safety hazard.
9. Replace/repair any remaining water-stained ceiling tiles. Examine the area above and around these areas for mold growth. Disinfect areas of water leaks with an appropriate antimicrobial.

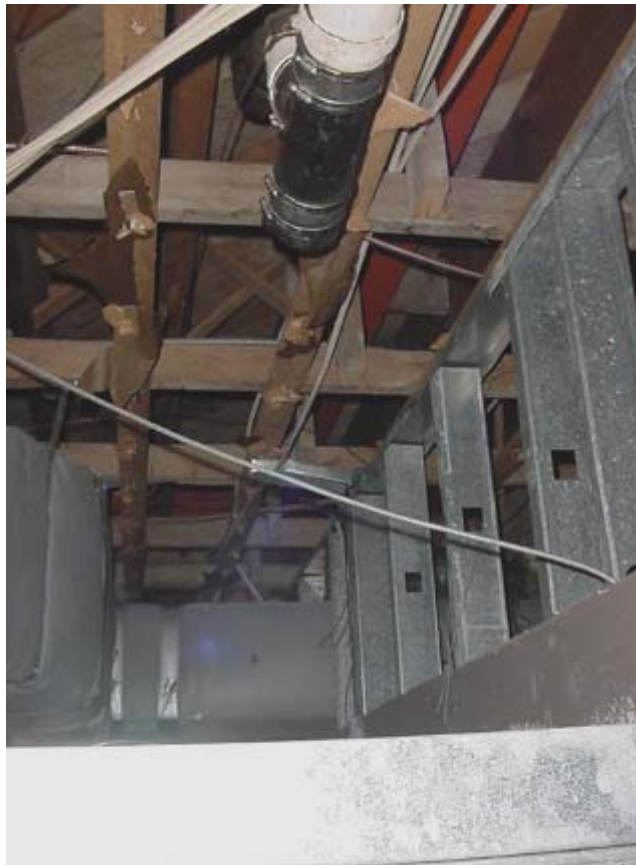
**Picture 7**

the time of the assessment and no evidence of current water damage or visible mold growth was observed in the ceiling plenum. If this leak has been repaired the drip pan should be removed.

**Plumbing (Top) and Metal Drip Pan (Bottom) above Ceiling Tiles in License Station 1**

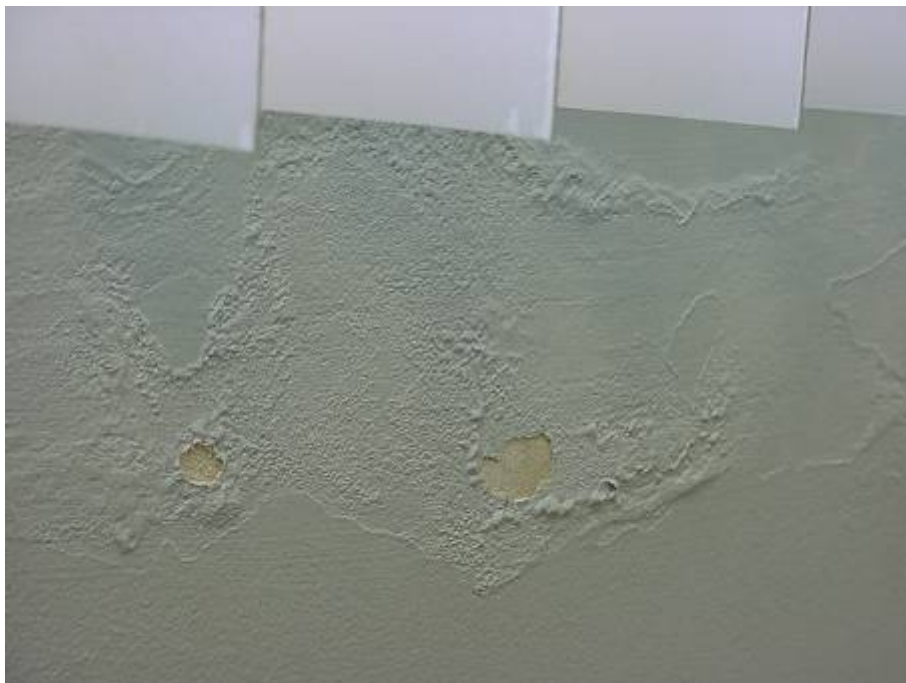
**Picture 8**

Evidence of water penetration through the building envelope was observed however along the front wall/Cabot Street side of the building [in the form of peeling paint and efflorescence (Pictures 8 and 9)]. Efflorescence is a characteristic sign of water damage to brick and mortar, but it is not mold growth. As moisture penetrates and works its way through mortar and brick, water-soluble compounds in mortar and brick dissolve, creating a solution. As the solution moves to the surface of the mortar or brick, the water evaporates, leaving behind white, powdery mineral deposits. At the time of the assessment water damaged wall materials along the front wall were found to have moderate to elevated moisture content indicating a moisture source (Table 1). During a perimeter inspection of the building, missing/damaged caulking was observed around windows along the front of the building (Pictures 10 and 11). In addition, the stucco exterior of the building had been damaged and exposed insulation material was observed (Picture 12), which may indicate a potential source of water penetration through the building envelope.

**Peeling Paint and Efflorescence along Front Wall below Windows**

5. Contact a masonry firm or building envelope specialist to examine the front exterior of the building and to repair any breaches in exterior walls to prevent water penetration.

6. Once leaks are repaired replace water-damaged wall board/building materials along the front of the building. Examine the wall cavity behind this area for mold growth. Disinfect areas of water leaks with an appropriate antimicrobial as needed.

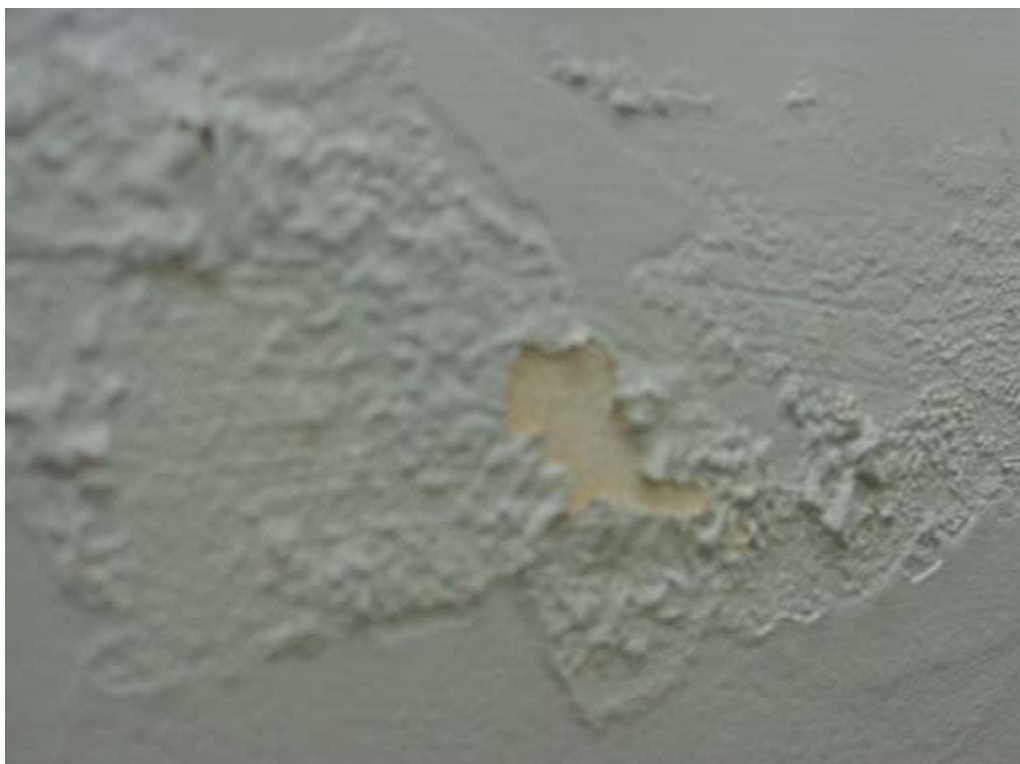
**Picture 9**

**Peeling Paint and Efflorescence along Front Wall below Windows**

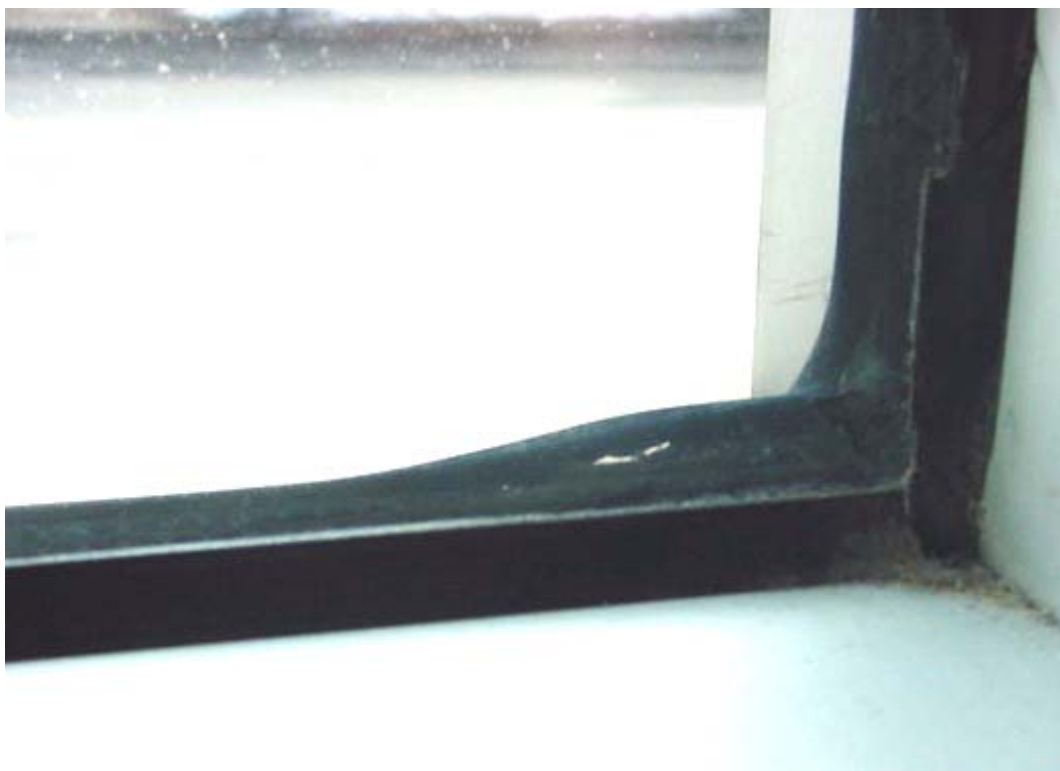
**Picture 10**

**Loose/Damaged Caulking along Front Windows**

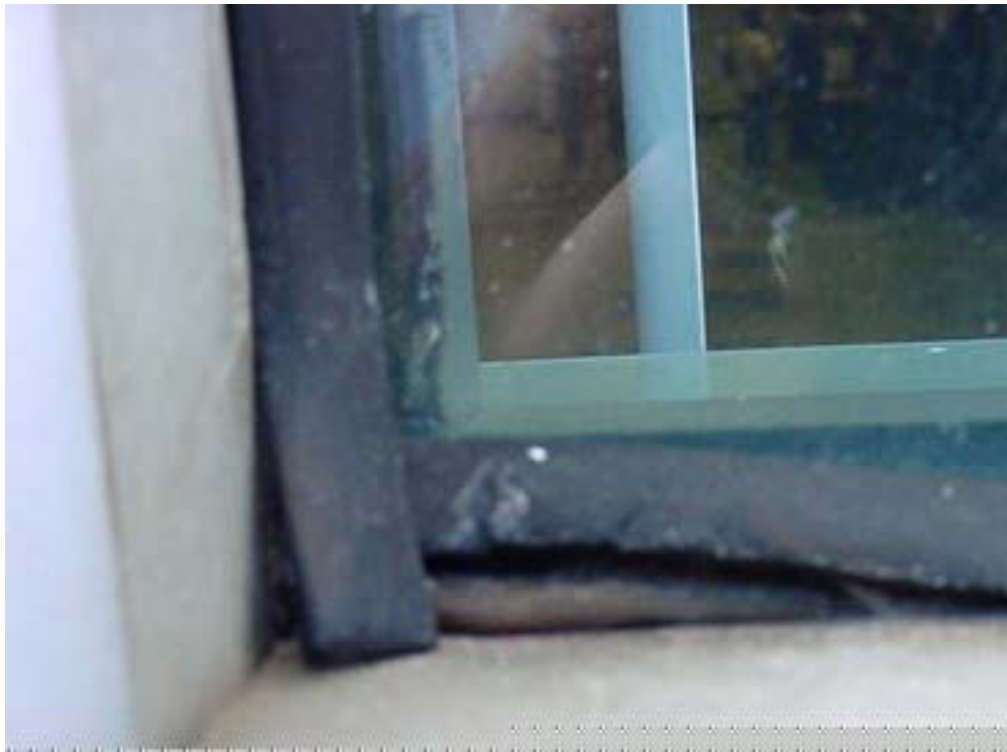
**Picture 11**

**Loose/Damaged Caulking along Front Windows**

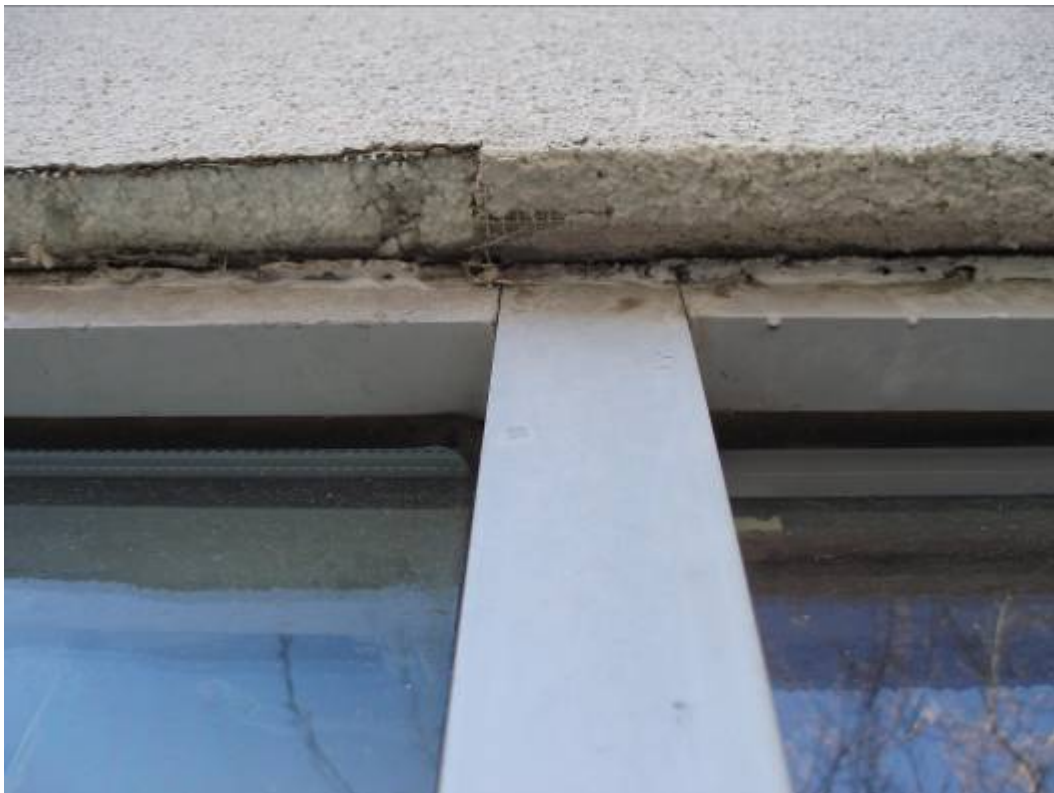
**Picture 12**

**Damaged Exterior Exposing Styrofoam Insulation Material**

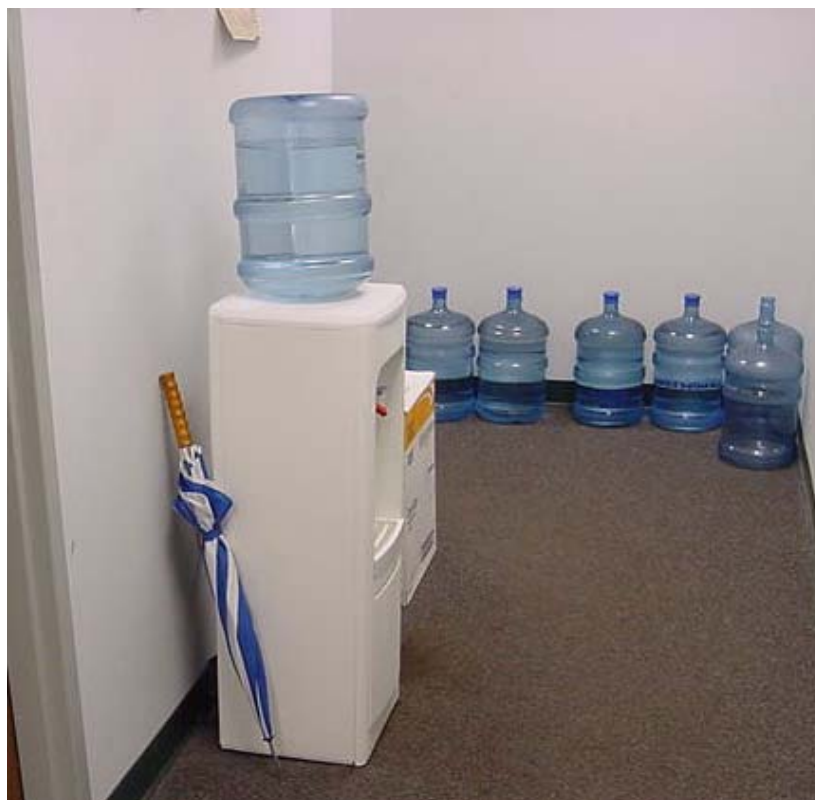
**Picture 13**

Water coolers and containers were observed directly on carpeting (Picture 13). Leakage of containers and/or overflow of cooler catch basins can result in the wetting of the carpet. In addition, some coolers had residue/build-up in the reservoir. These reservoirs are designed to catch excess water during operation and should be emptied/cleaned regularly to prevent microbial and/or bacterial growth.

**Water Cooler and Bottles on Carpet**

12. Relocate or place tile or rubber matting underneath water coolers and containers in carpeted areas. Clean and disinfect reservoirs as needed to prevent microbial growth.

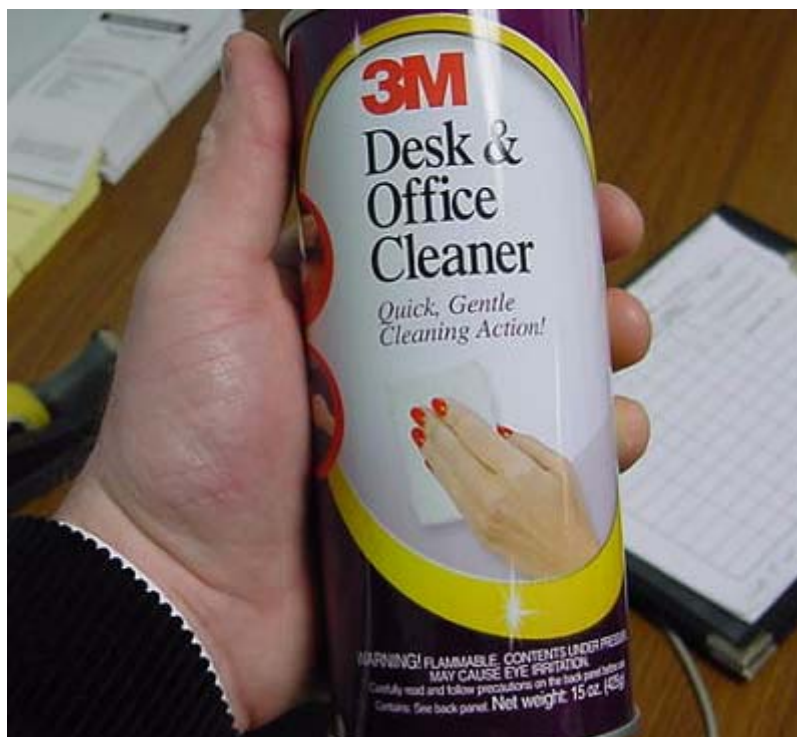
**Picture 14**

Several other conditions that can affect indoor air quality were observed during the assessment. VOC-containing cleaning materials were observed in work areas presumably to clean personal work space (Picture 14). This particular cleaning agent contains several VOCs (e.g., isopropyl alcohol and monoethanolamine) that can be irritating to the eyes, nose and throat (3M, 2000) (Picture 15).

**VOC-Containing Cleaning Agent, Note Label Warning: May Cause Eye Irritation**

16. Refrain from or reduce the use of VOC-containing cleaning materials.
17. Clean carpeting annually or semi-annually in high traffic areas as per the recommendations of the Institute of Inspection, Cleaning and Restoration Certification (IICRC). Copies of the IICRC fact sheet can be downloaded at:  
[http://www.cleancareseminars.com/carpet\\_cleaning\\_faq4.htm](http://www.cleancareseminars.com/carpet_cleaning_faq4.htm) (IICRC, 2005).

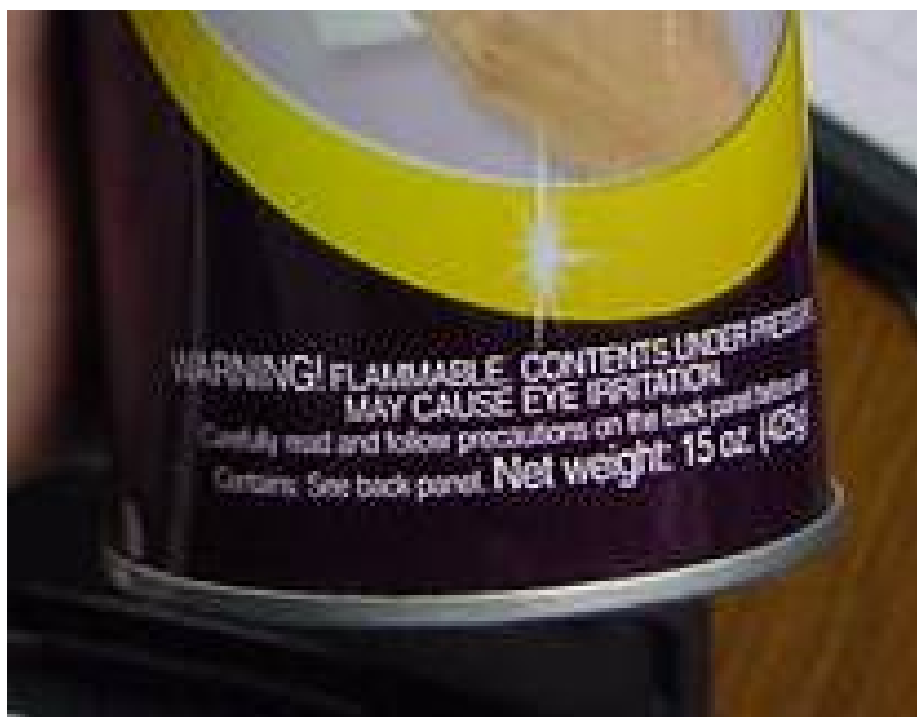
**Picture 15**

**Close Up of Label Warning: May Cause Eye Irritation**

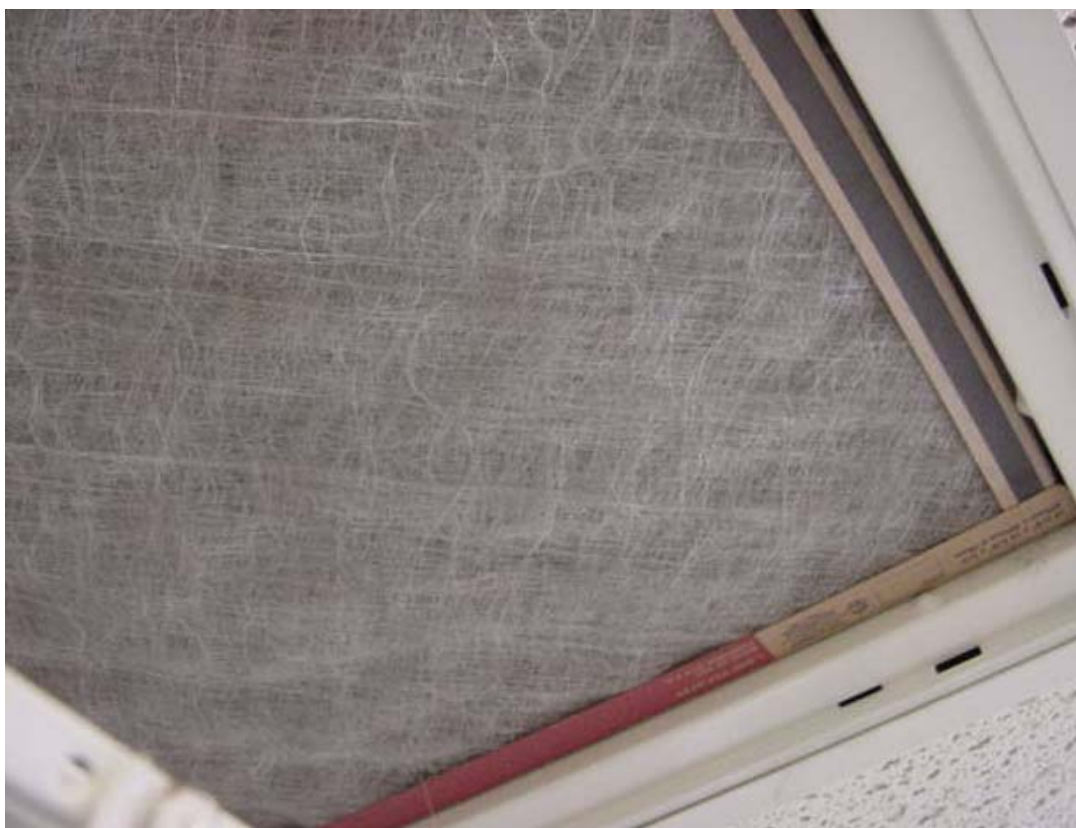
**Picture 16**

The HVAC filters installed at the RMV are of a type that provides minimal filtration (Picture 16). In order to decrease aerosolized particulates, higher efficiency filters can be installed. The dust spot efficiency is the ability of a filter to remove particulates of a certain diameter from air passing through the filter. Filters that have been determined by ASHRAE to meet its standard for a dust spot efficiency of a minimum of 40 percent (Minimum Efficiency Reporting Value equal to 9) would be sufficient to reduce many airborne particulates (Thornburg, 2000; MEHRC, 1997; ASHRAE, 1992). Note that increasing filtration can reduce airflow, a condition known as pressure drop. A drop in pressure can subsequently reduce efficiency due to increased resistance. Prior to any increase of filtration, each AHU should be evaluated by a ventilation engineer to ascertain whether it can maintain function with more efficient filters.

**Fibrous Mesh Filter Installed in Return Vents**

13. Clean personal fans, supply, return and restroom exhaust vents periodically of accumulated dust.
14. Change filters for air-handling equipment as per the manufacturer's instructions or more frequently if needed. Consider upgrading to higher efficiency pleated filters.

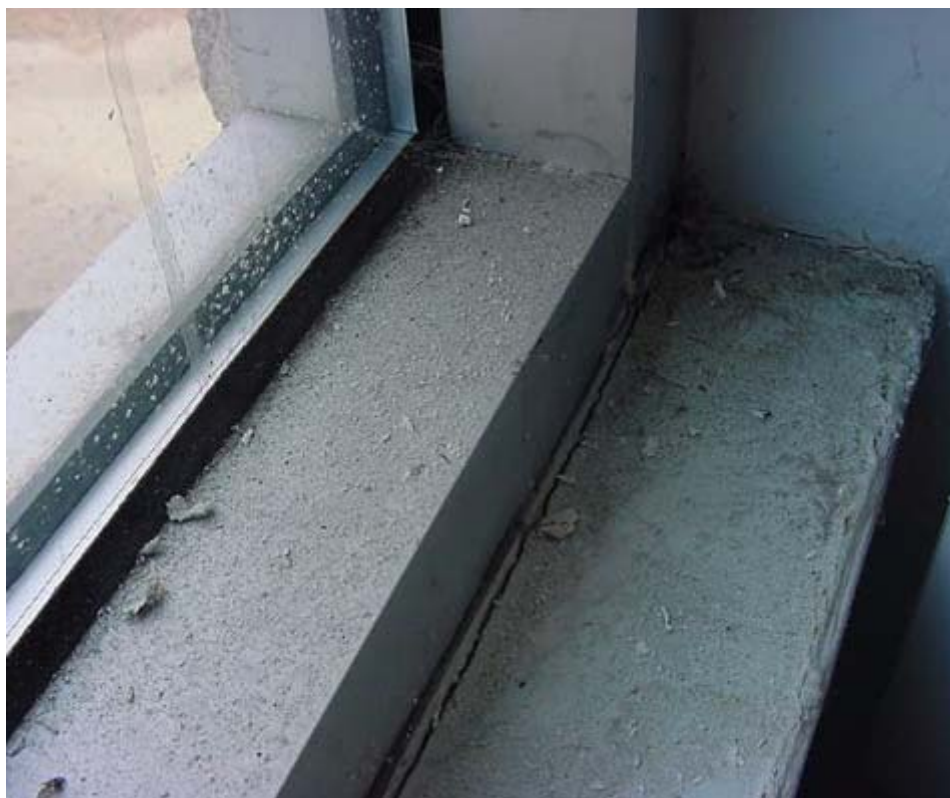
**Picture 17**

Also of note was the amount of materials stored inside offices and common areas. In areas throughout the RMV, items were observed on windowsills, tabletops, counters, bookcases and desks. The large number of items stored provides a source for dusts to accumulate (Pictures 17 and 18). These items, (e.g., papers, folders, boxes) make it difficult for custodial staff to clean. Dust can be irritating to eyes, nose and respiratory tract. Items should be relocated and/or be cleaned periodically to avoid excessive dust build up.

**Dust/Debris Accumulation on Flat Surfaces in Office**

15. Relocate or consider reducing the amount of materials stored in offices and common areas to allow for more thorough cleaning. Clean items regularly with a wet cloth or sponge to prevent excessive dust build-up.

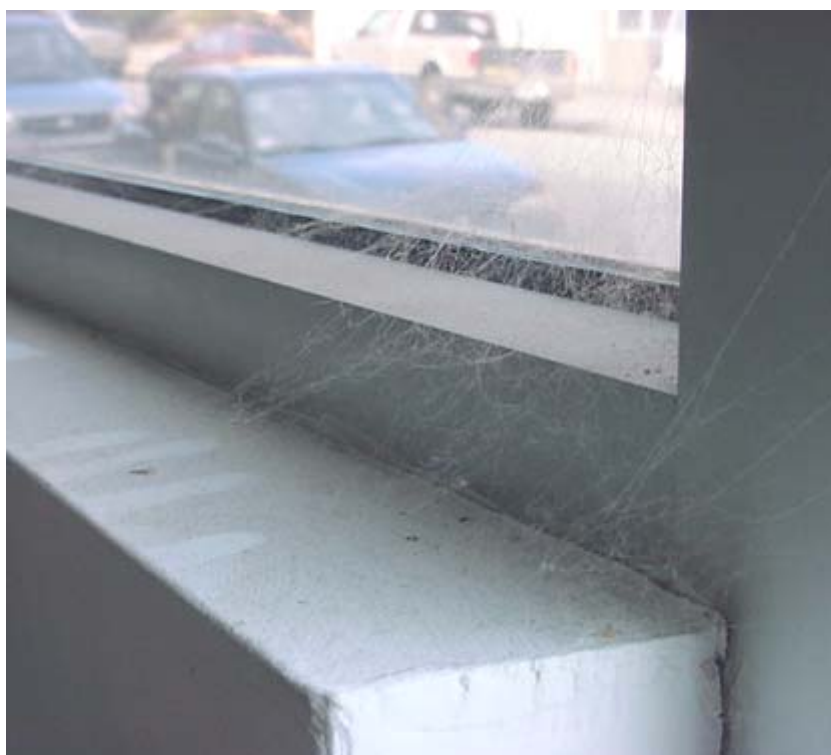
**Picture 18**

**Cobwebs, Dust/Debris Accumulation on Flat Surfaces in Office**

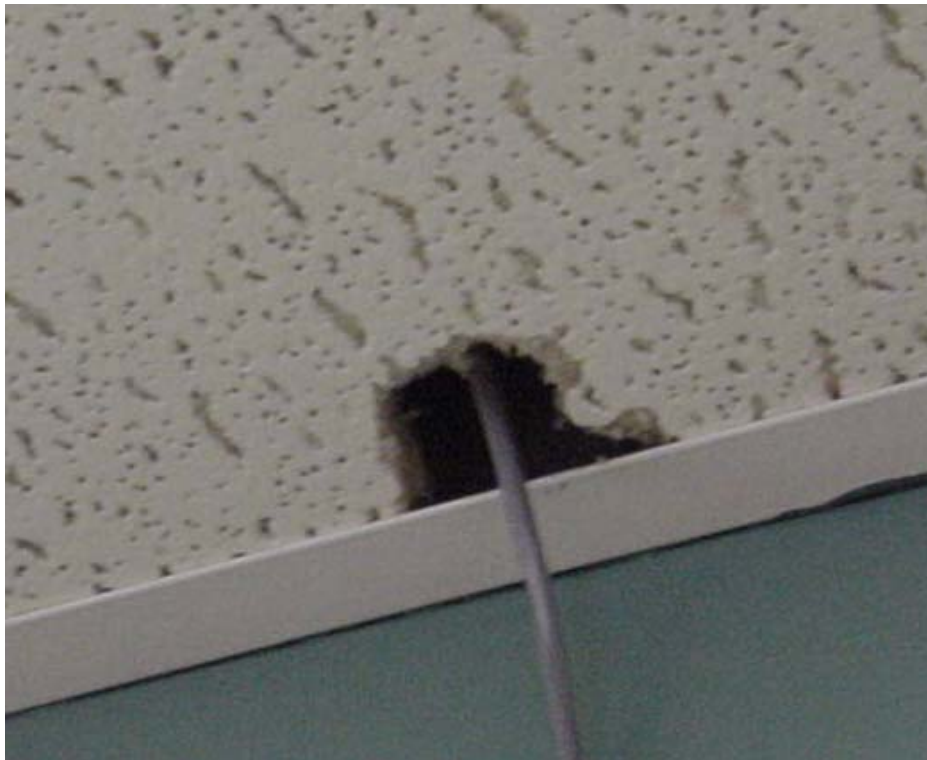
**Picture 19**

Missing/damaged ceiling tiles were observed in several areas (Pictures 19). Missing or damaged ceiling tiles can provide a pathway for the movement of odors, fumes and particulates from the ceiling plenum into occupied areas.

**Hole in Ceiling Tile**

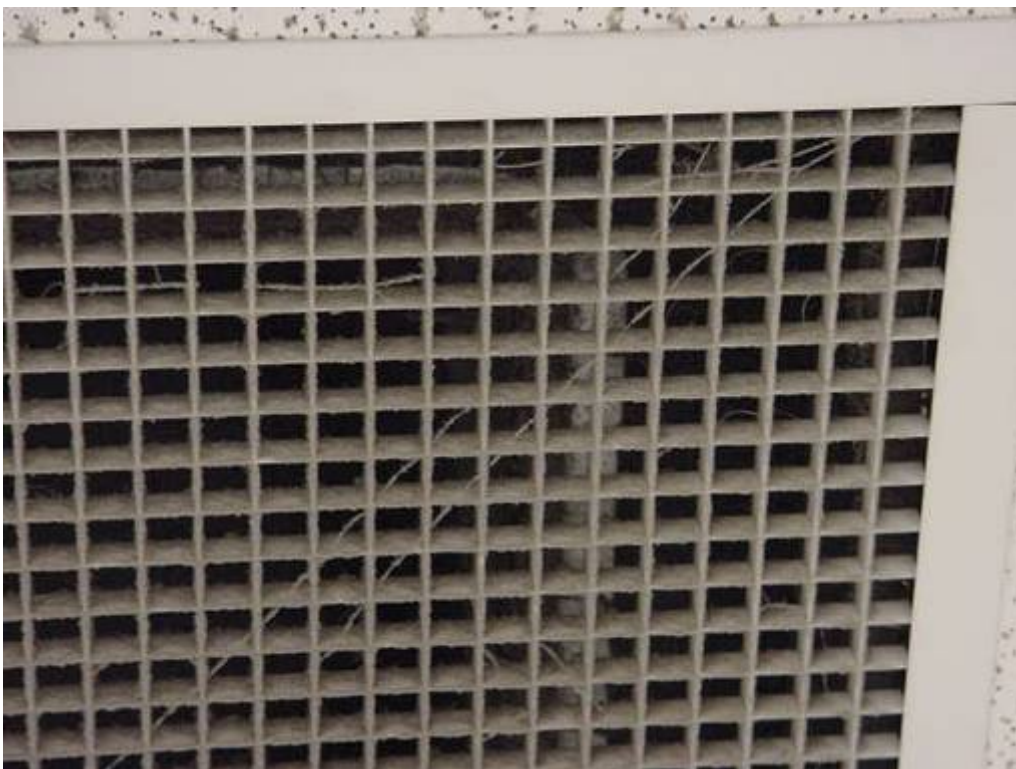
**Picture 20**

Finally, personal fans, return and exhaust vents in offices and restrooms had accumulated dust (Picture 20). If exhaust vents are not functioning, backdrafting can occur,

**Cobwebs, Dust and Debris on Return Vent**
